Aquatic Resources Delineation

Proposed Milan Bottoms / Bally West Development

Rock Island, Rock Island County, Illinois

Terracon Project No. CJ257097

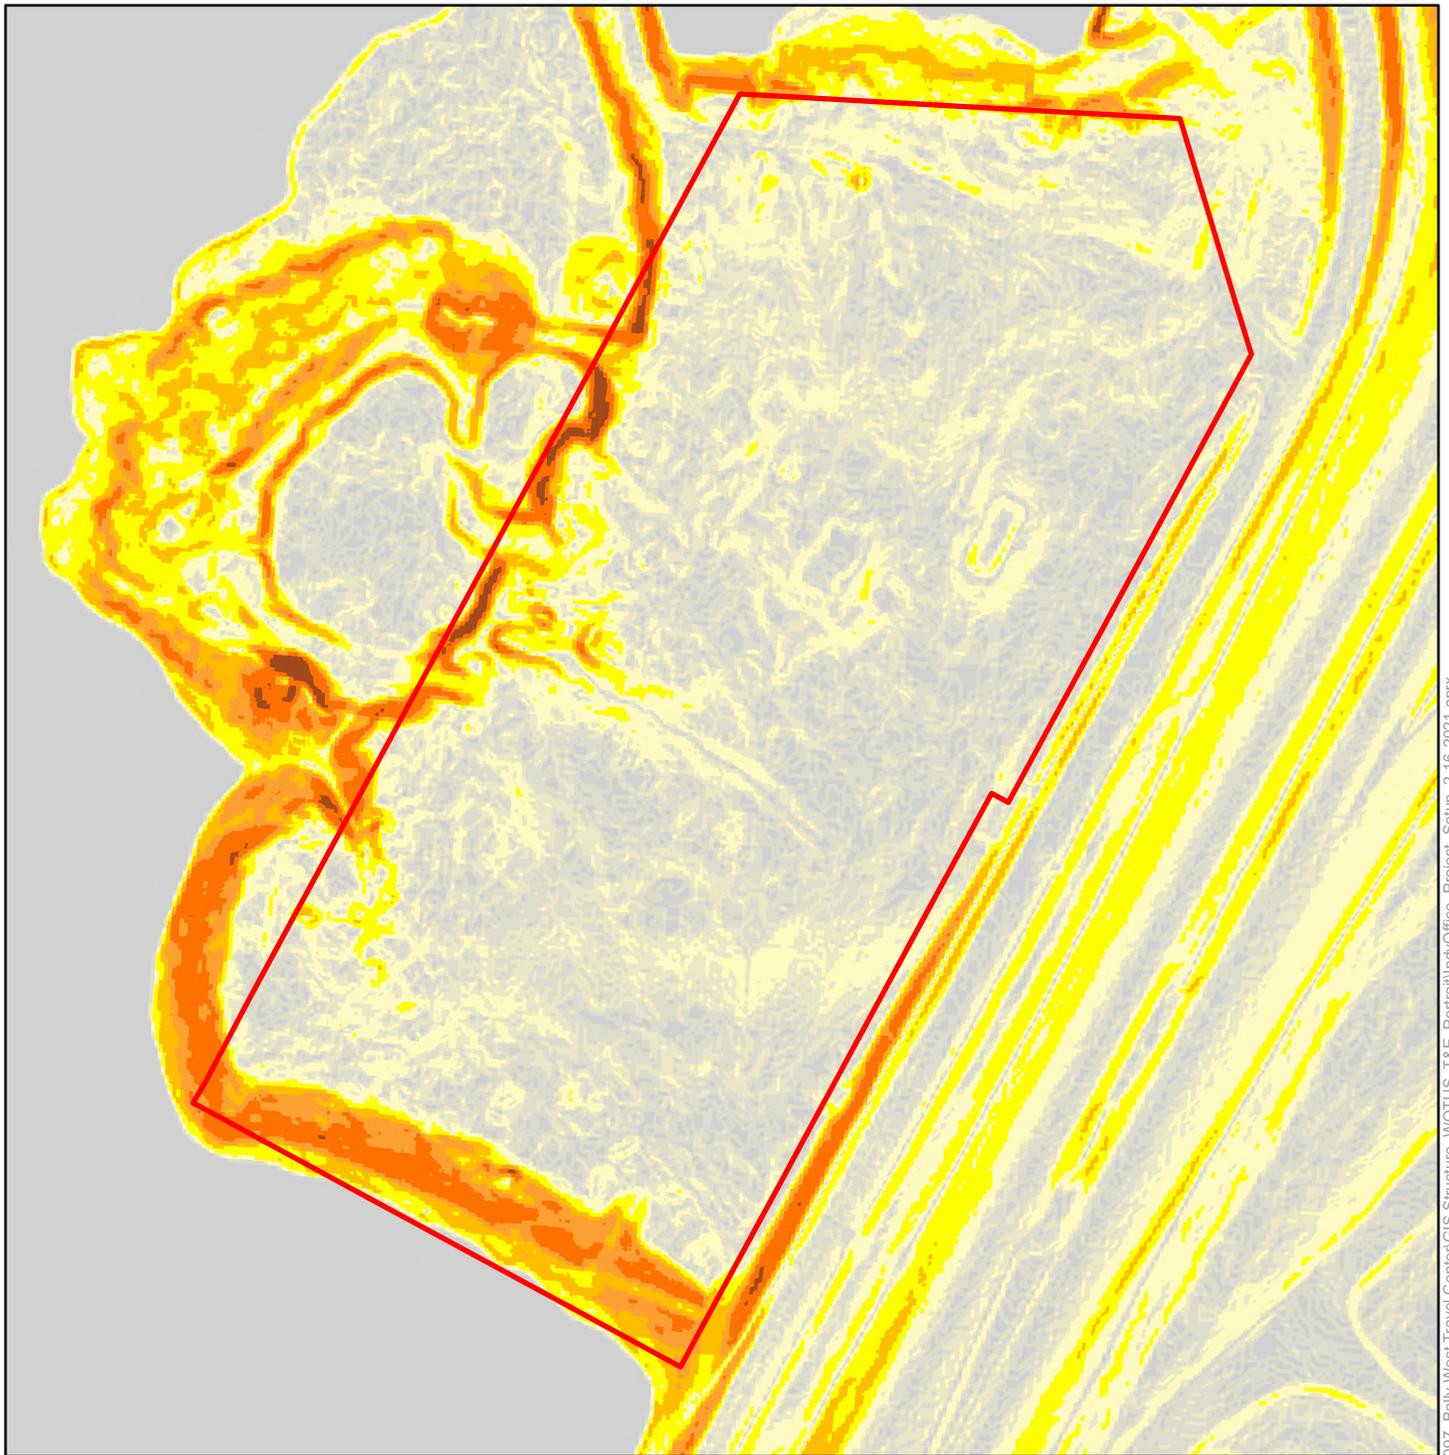
Exhibit
3.0

- Study Area
- Flat (0°)
- Nearly level (1°)
- Gently level (2°)
- Gently sloping (3° - 5°)
- Strongly sloping (6° - 10°)
- Gently steep (11° - 15°)
- Moderately Steep (16° - 20°)
- Steep (21° - 30°)
- Very steep (31° - 90°)

DEM Slope Map
Bally West / Milan Bottoms Development Rock Island, Rock Island County, Illinois Center 90.6186°W 41.4604°N

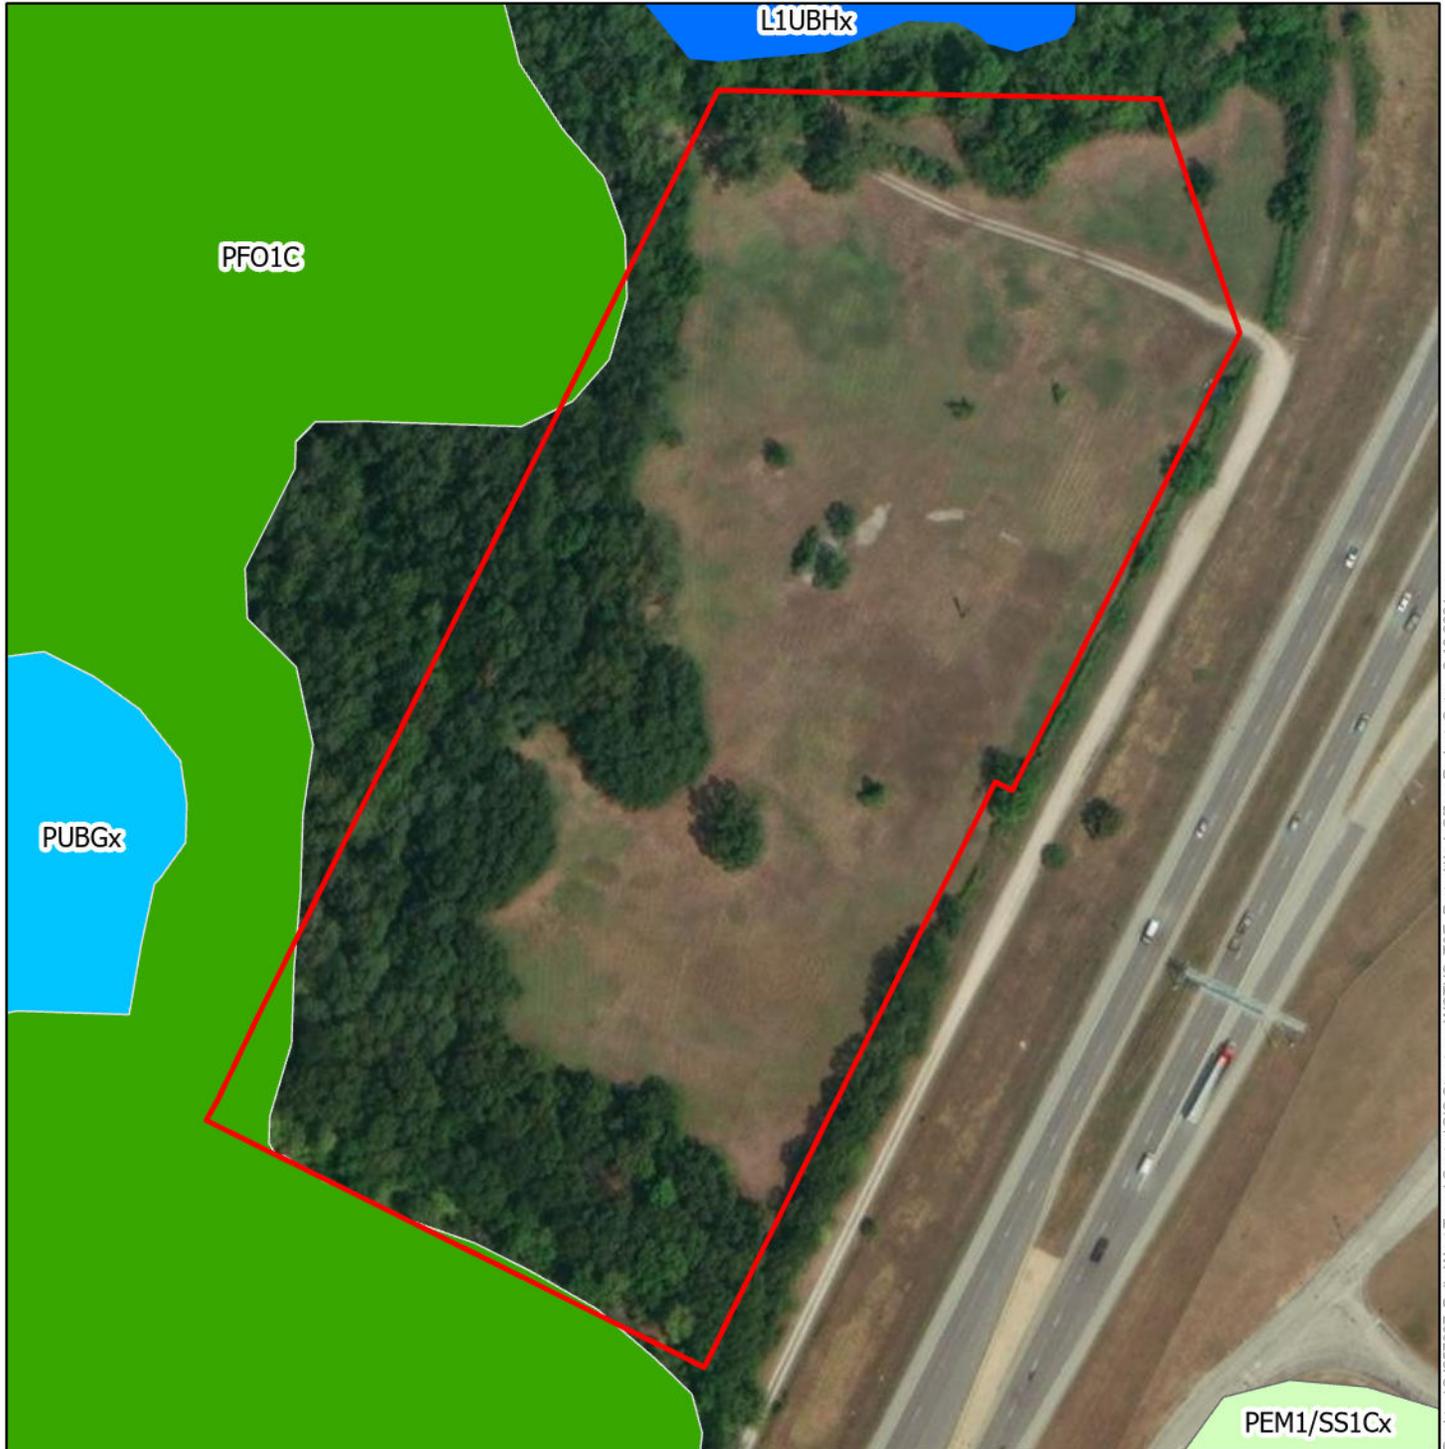
Exhibit
4.0

- Study Area
- Lake
- Freshwater Emergent Wetland
- Freshwater Forested/Shrub Wetland
- Freshwater Pond

NWI Map
Bally West / Milan Bottoms Development Rock Island, Rock Island County, Illinois Center 90.6186°W 41.4604°N

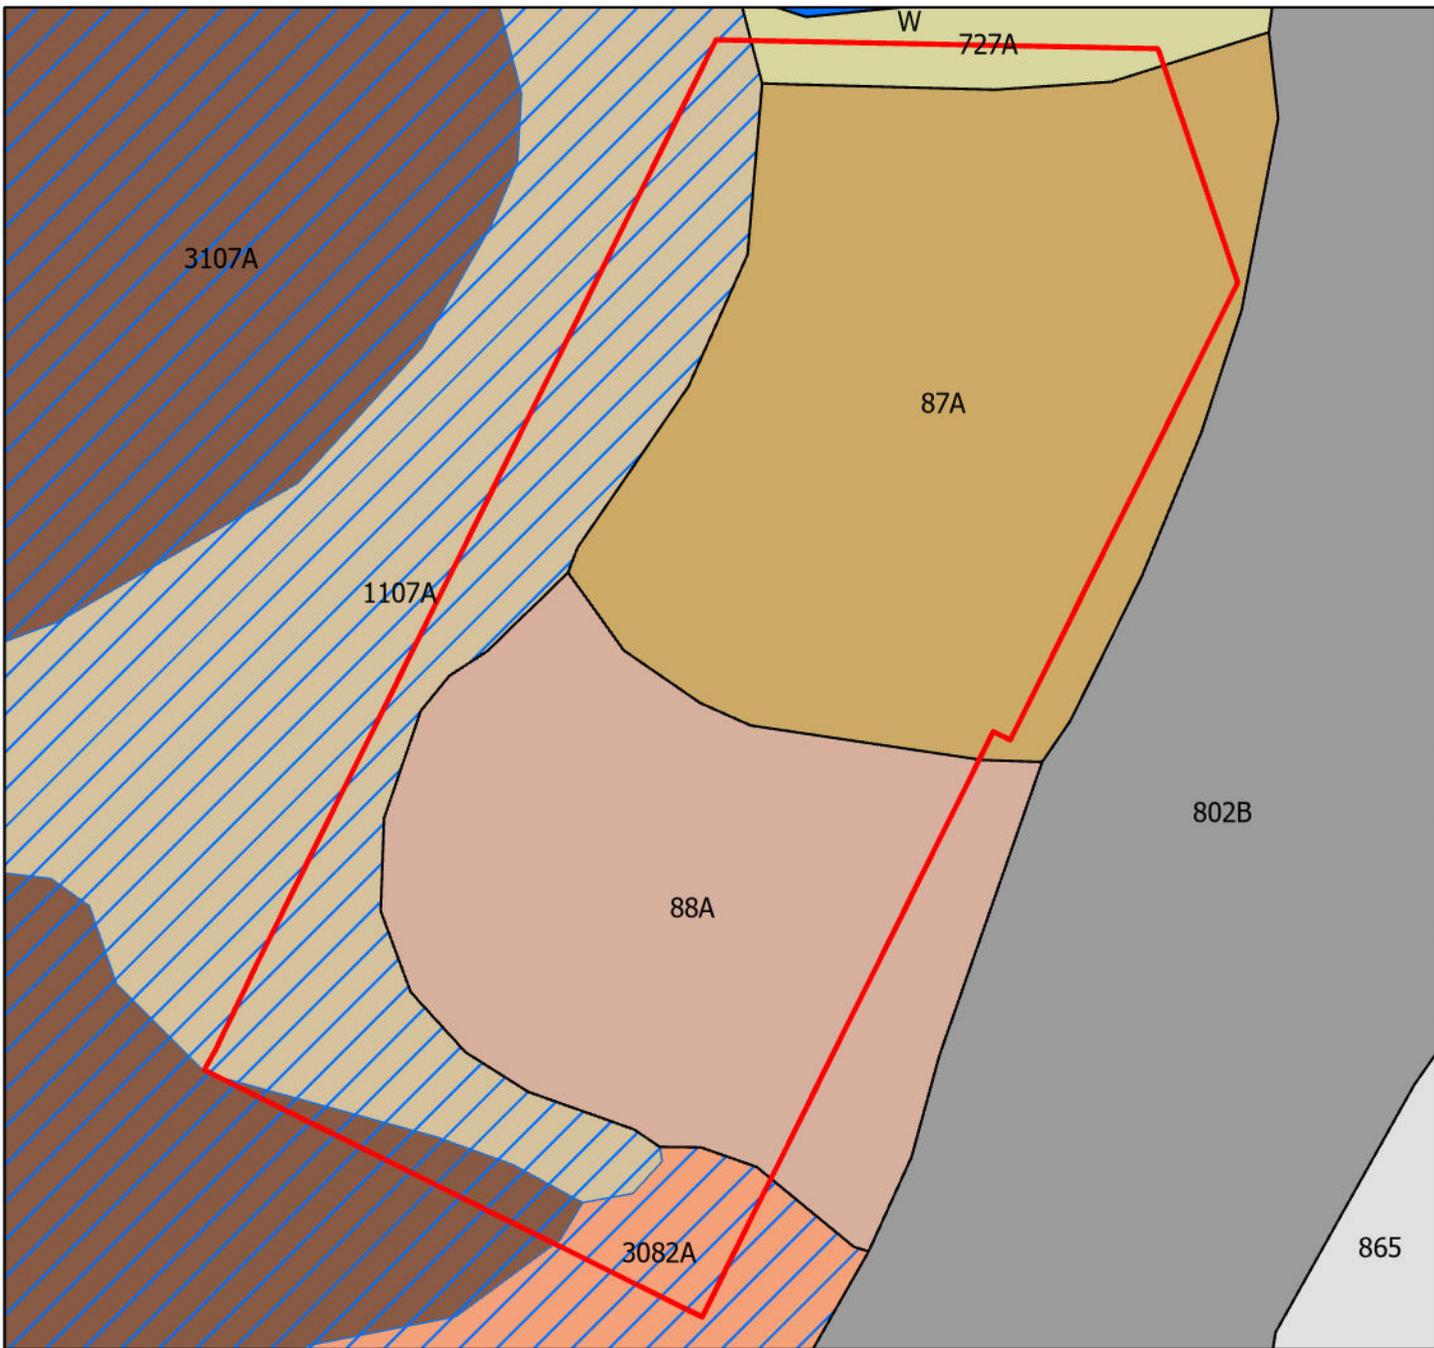
5.0

- Study Area
- 727A: Waukee loam, 0 to 2 percent slopes
- 87A: Dickinson sandy loam, 0 to 2 percent slopes
- 88A: Sparta loamy sand, Illinois till plain, 0 to 2 percent slopes
- 3082A: Millington silt loam, 0 to 2 percent slopes, frequently flooded
- 3107A: Sawmill silty clay loam, 0 to 2 percent slopes, frequently flooded
- 1107A: Sawmill silty clay loam, undrained, 0 to 2 percent slopes, frequently flooded
- 865: Pits, gravel
- 802B: Orthents, loamy, undulating
- W: Water
- Hydric
- Non Hydric

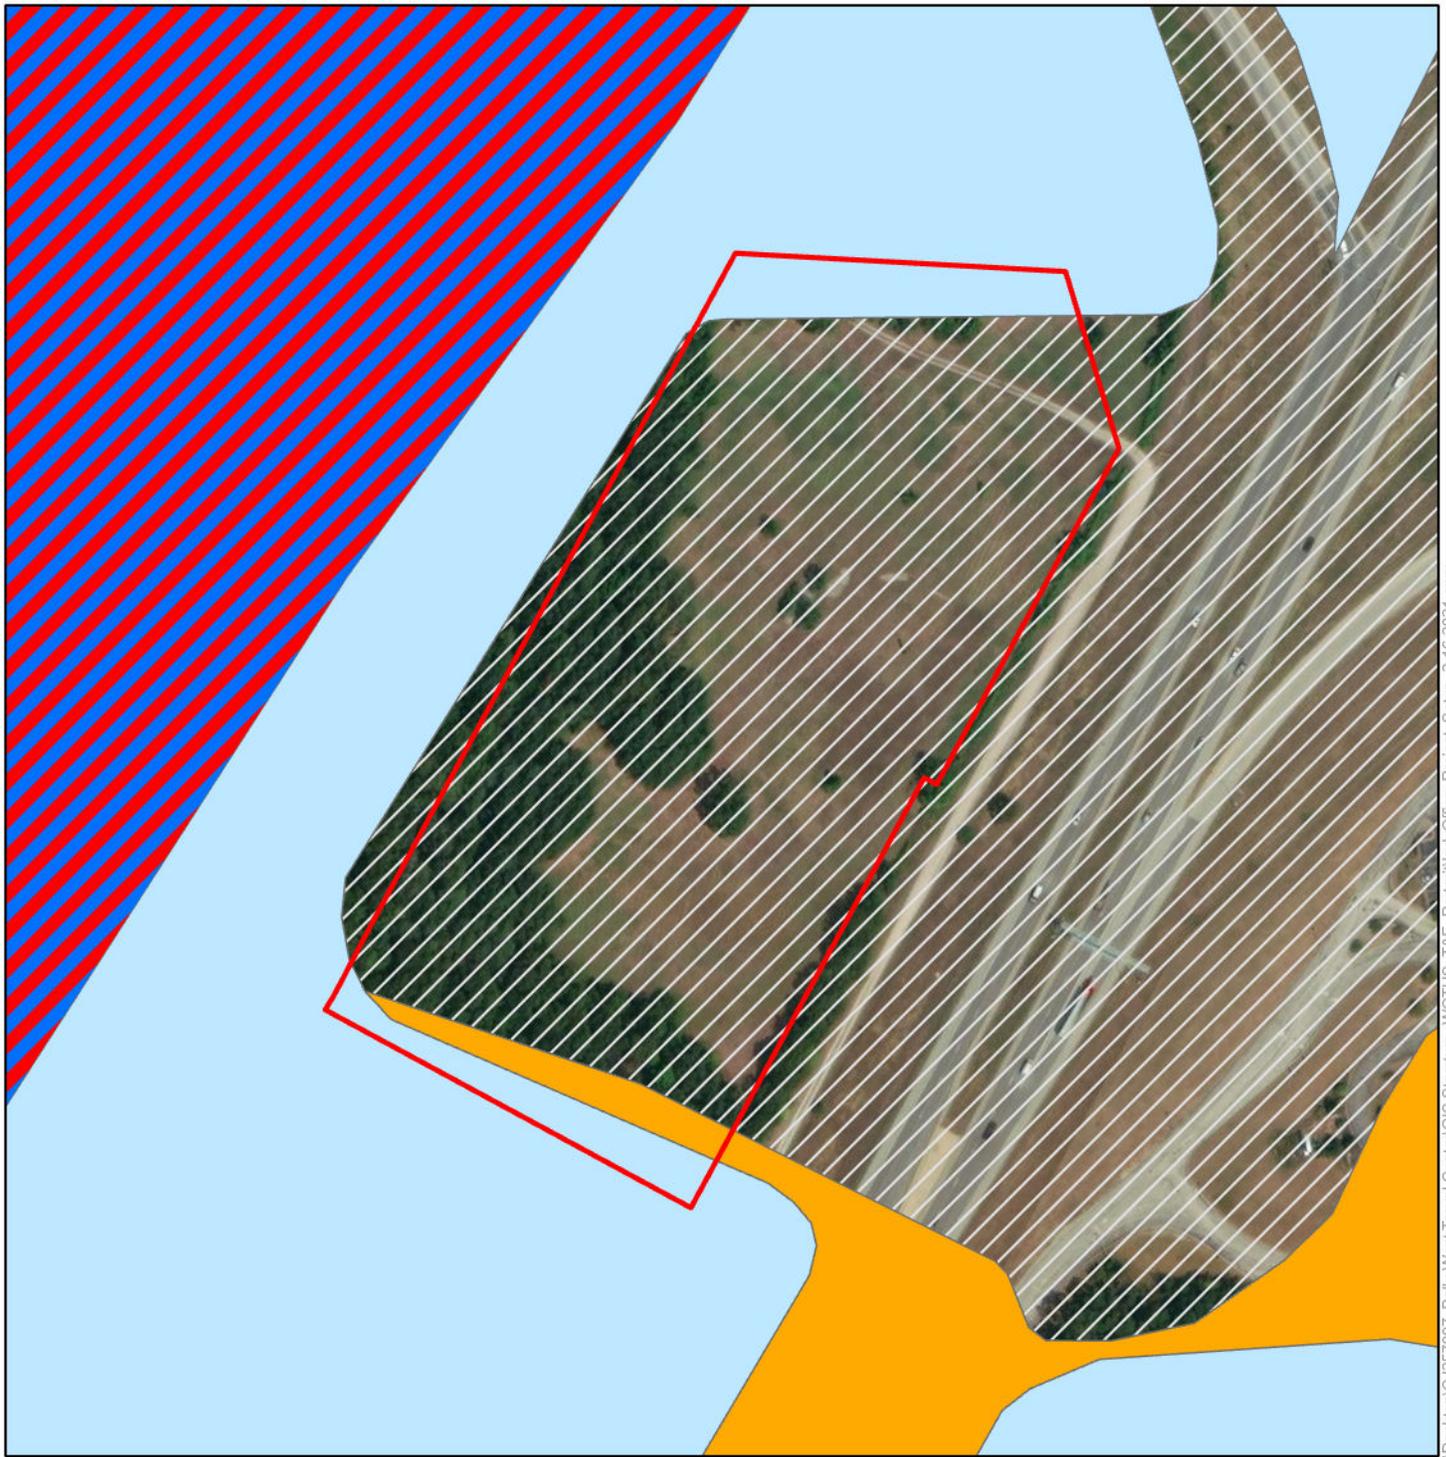
6.0

- Study Area
- Zone X (unshaded): Area of Minimal Flood Hazard
- Zone X: 0.2% Annual Chance Flood Hazard
- Zone AE: 1% Annual Chance Flood Hazard
- Zone AE: Regulatory Floodway

Terracon downloaded and reviewed FEMA National Flood Hazard Layer (NFHL) panel 17161C0305F, effective April 5, 2010. According to the NFHL, the majority of the study area is depicted within Zone X (unshaded): area of minimal flood hazard. The sections of the study area along the southern boundary lie within the 500-year floodplain, Zone X (shaded): 0.2% annual chance flood hazard, and the 100-year floodplain, Zone AE: 1% annual chance flood hazard. Additionally, the northern study area boundary lies within the 100-year flood plain, Zone AE. A map depicting the digital NFHL and IDNR data is included as *Exhibit 6.0* in *Appendix A*.

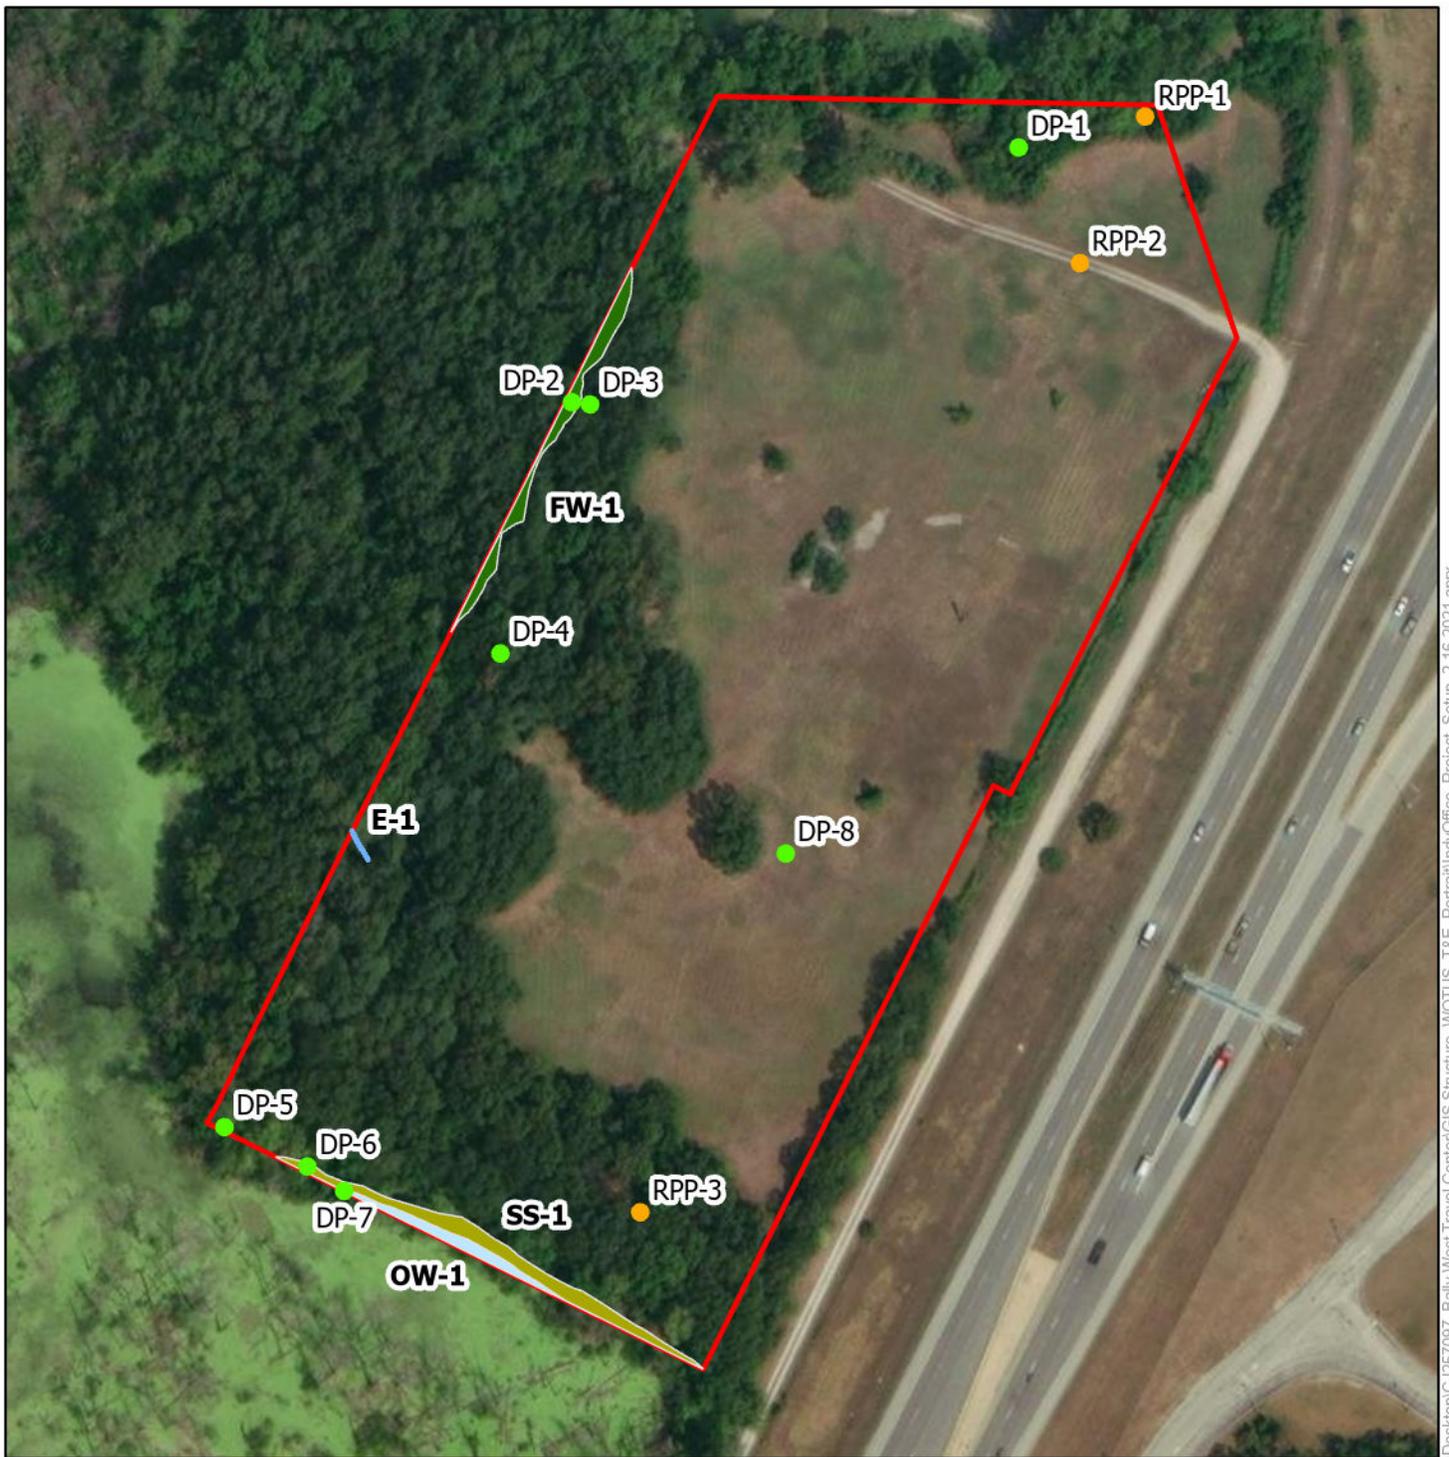
- Study Area
- Forested Wetland
- Scrub / Shrub Wetland
- Open Water / Slough
- Ephemeral Stream
- Data Point
- Reference Photo Point

- **E-1:** Terracon identified one ephemeral stream (E-1) along the western boundary which originated on-site and continued offsite through a culvert which discharged to the abutting forested wetland. The OHWM of E-1 was four feet. Vegetation was largely absent from the streambed; however, leaf litter was observed within the OHWM. E-1 is not considered a navigable water or water with a relatively permanent flow regime. Therefore, E-1 is likely to be considered non-jurisdictional by the USACE.

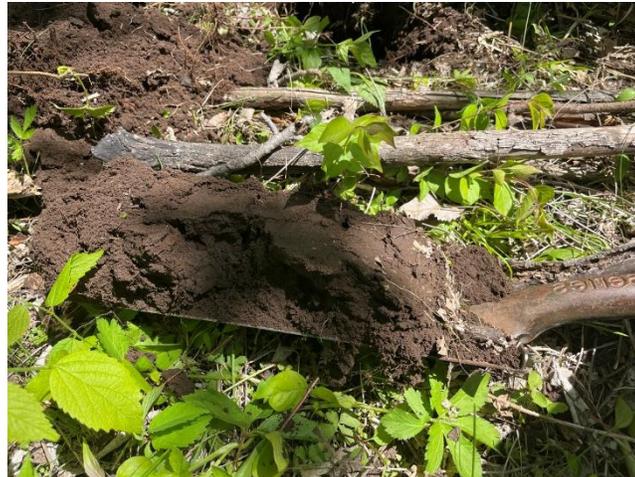
DP-1 Soil Profile

Profile Description: (Describe to the depth needed to document the indicator or confirm the absence of indicators.)								
Depth (inches)	Matrix		Redox Features				Texture	Remarks
	Color (moist)	%	Color (moist)	%	Type ¹	Loc ²		
0-16	10 YR 3/2	100					sandy loam

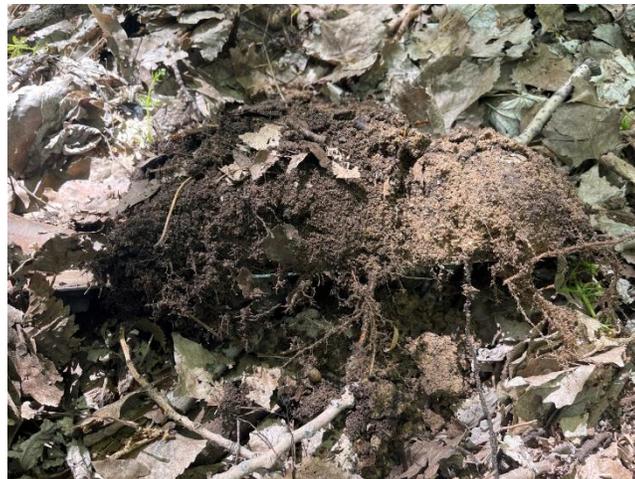
DP-2 Soil Profile

Profile Description: (Describe to the depth needed to document the indicator or confirm the absence of indicators.)								
Depth (inches)	Matrix		Redox Features				Texture	Remarks
	Color (moist)	%	Color (moist)	%	Type ¹	Loc ²		
0-6	10YR 2/1	70	10YR 6/1	30	D	M	Sandy	sandy loam
6-16	10YR 4/2	25	10YR 6/6	5	C	M	Sandy	sandy loam
			10YR 5/1	70	D	M

Restrictive Layer (if observed): Type: _____ Depth (inches): _____	Hydric Soil Present? Yes <input checked="" type="checkbox"/> No <input type="checkbox"/>
---	---

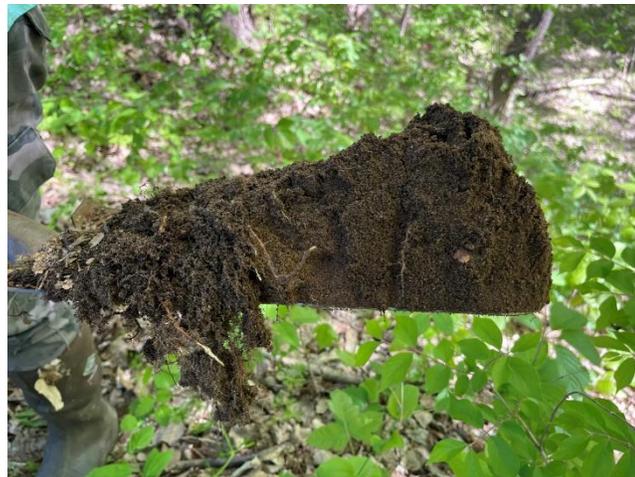
DP-3 Soil Profile

Profile Description: (Describe to the depth needed to document the indicator or confirm the absence of indicators.)								
Depth (inches)	Matrix		Redox Features				Texture	Remarks
	Color (moist)	%	Color (moist)	%	Type ¹	Loc ²		
0-16	10YR 3/3	100					Sandy	sandy loam

<p>Restrictive Layer (if observed):</p> <p>Type: _____</p> <p>Depth (inches): _____</p>	<p>Hydric Soil Present? Yes <input type="checkbox"/> No <input checked="" type="checkbox"/></p>
--	--

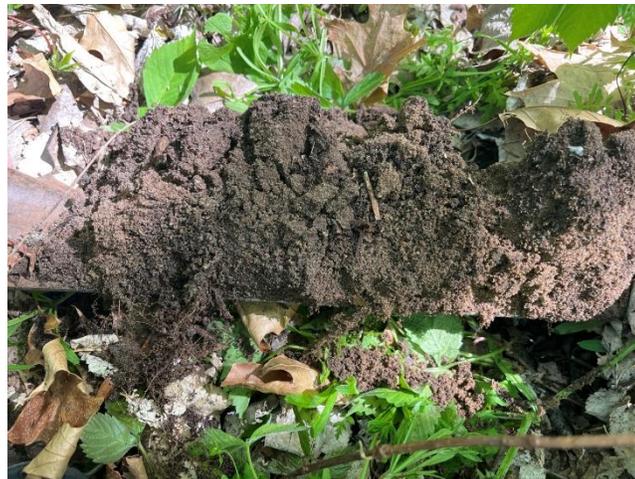
DP-4 Soil Profile

Profile Description: (Describe to the depth needed to document the indicator or confirm the absence of indicators.)								
Depth (inches)	Matrix		Redox Features				Texture	Remarks
	Color (moist)	%	Color (moist)	%	Type ¹	Loc ²		
0-10	10YR 3/2	100					Sandy	sandy loam
10-16	10YR 4/4	100					Sandy	sand

Restrictive Layer (if observed): Type: _____ Depth (inches): _____	Hydric Soil Present? Yes _____ No <u>x</u>
---	---

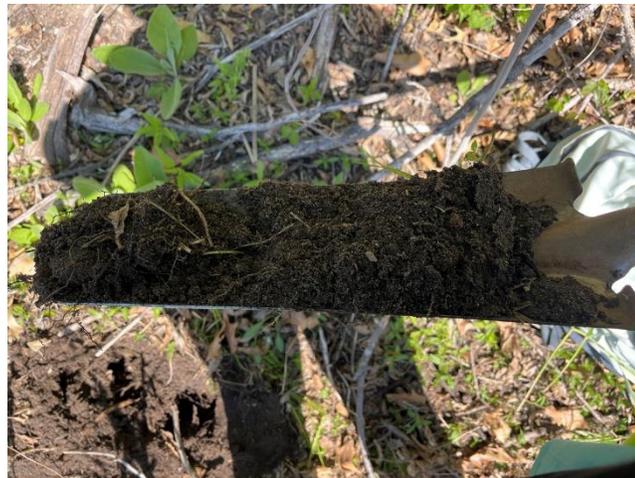
DP-5 Soil Profile

Profile Description: (Describe to the depth needed to document the indicator or confirm the absence of indicators.)								
Depth (inches)	Matrix		Redox Features				Texture	Remarks
	Color (moist)	%	Color (moist)	%	Type ¹	Loc ²		
0-16	10YR 2/2	78	10YR 4/6	2	C	PL	Sandy	sandy loam
			10YR 5/2	20	D	M

Restrictive Layer (if observed): Type: _____ Depth (inches): _____	Hydric Soil Present? Yes <input checked="" type="checkbox"/> No _____
---	--

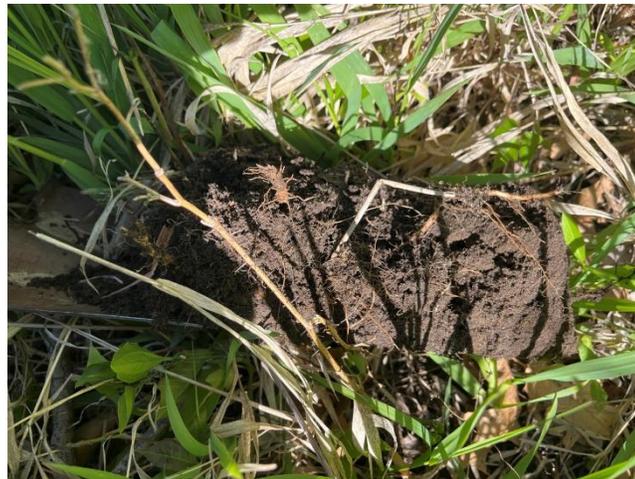
DP-6 Soil Profile

Profile Description: (Describe to the depth needed to document the indicator or confirm the absence of indicators.)								
Depth (inches)	Matrix		Redox Features				Texture	Remarks
	Color (moist)	%	Color (moist)	%	Type ¹	Loc ²		
0-16	10YR 2/2	95	10YR 4/4	5	C	PL/M	Sandy	sandy loam

<p>Restrictive Layer (if observed):</p> <p>Type: _____</p> <p>Depth (inches): _____</p>	<p>Hydric Soil Present? Yes <input checked="" type="checkbox"/> No <input type="checkbox"/></p>
--	--

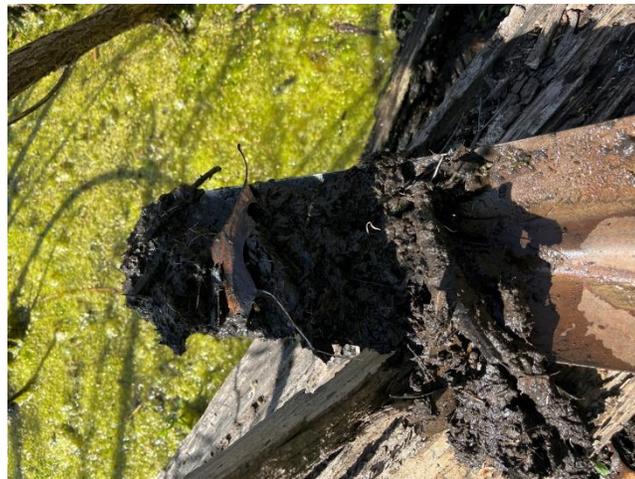
DP-7 Soil Profile

Profile Description: (Describe to the depth needed to document the indicator or confirm the absence of indicators.)							
Depth (inches)	Matrix		Redox Features			Texture	Remarks
	Color (moist)	%	Color (moist)	%	Type ¹		
0-2	10YR 3/1	100				Muck	
2-16	10YR 3/1	100				Mucky Peat

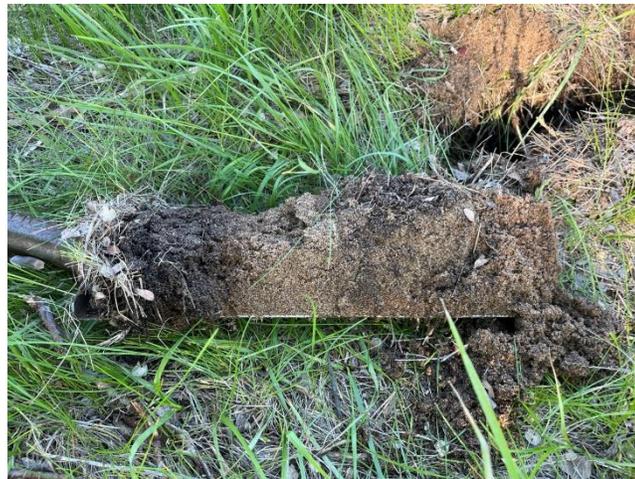
DP-8 Soil Profile

Profile Description: (Describe to the depth needed to document the indicator or confirm the absence of indicators.)								
Depth (inches)	Matrix		Redox Features				Texture	Remarks
	Color (moist)	%	Color (moist)	%	Type ¹	Loc ²		
0-2	10YR 2/1	100					Sandy	sandy loam
2-5	10YR 5/3	50	10YR 6/2	50	D	M	Sandy	sand
5-16	10YR 4/2	90	10YR 6/2	10	D	M	Sandy	sandy loam

<p>Restrictive Layer (if observed):</p> <p>Type: _____</p> <p>Depth (inches): _____</p>	<p>Hydric Soil Present? Yes <input checked="" type="checkbox"/> No <input type="checkbox"/></p>
--	--
